# Knee Chondral Repair: Review of Surgical Techniques and Post-Operative MR

Rakesh Patel, MD

4/9/09

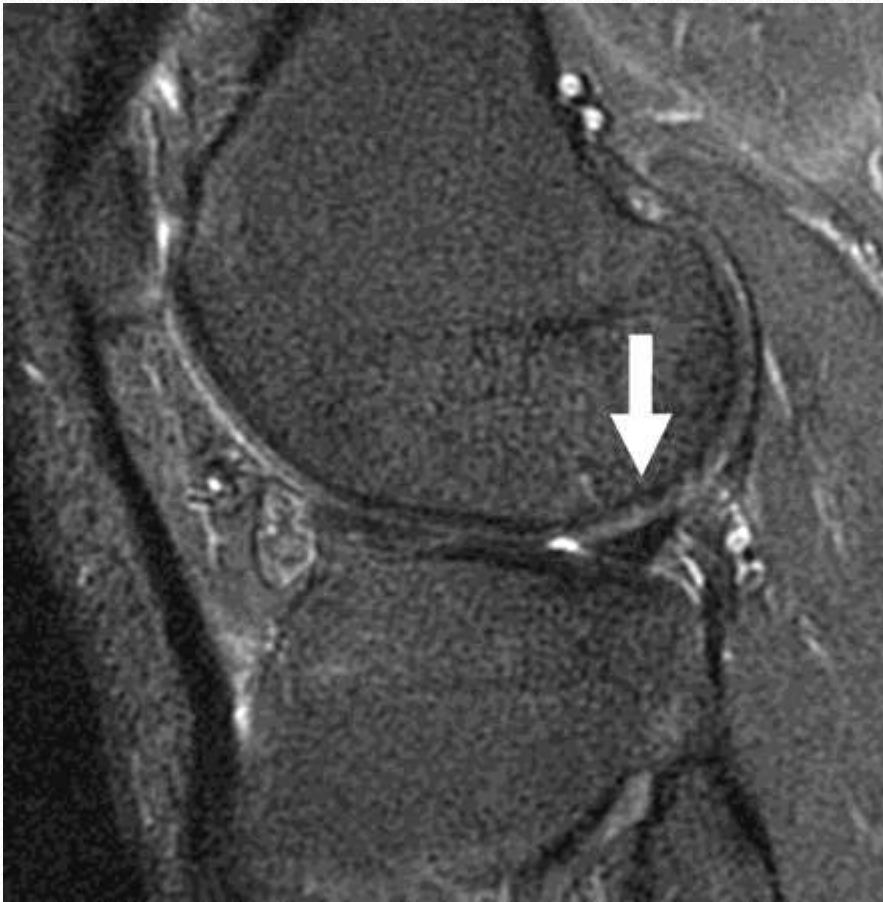
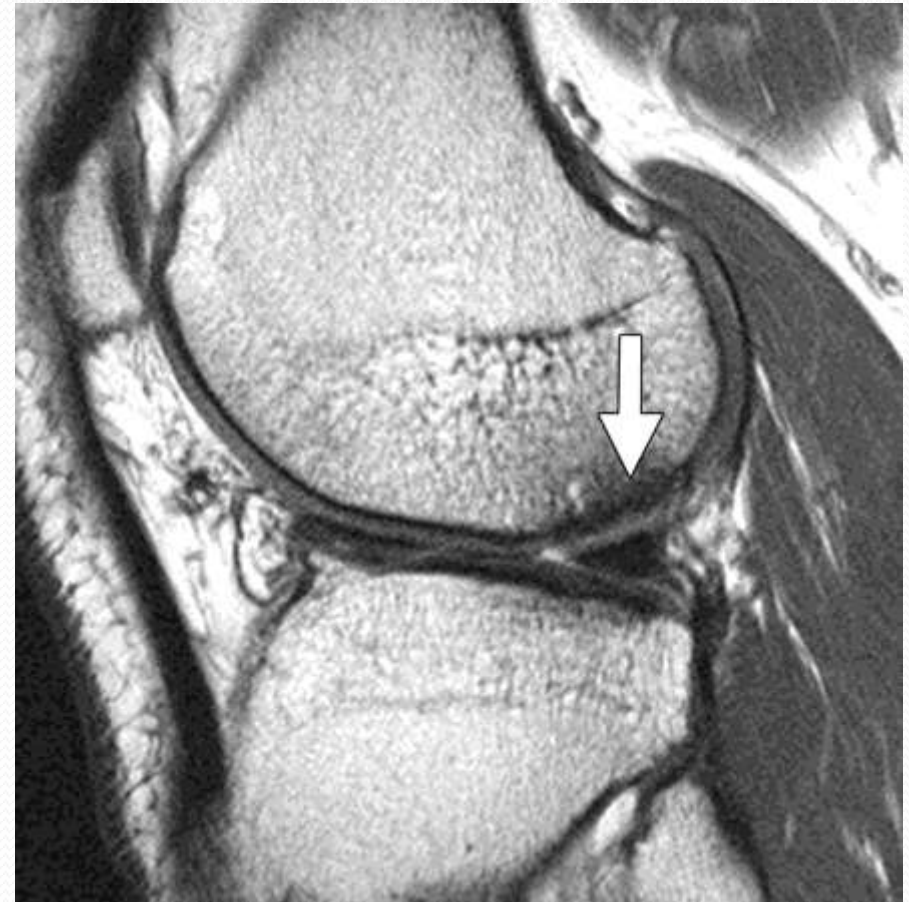
Sagittal inversion-recovery fast SE and sagittal intermediate-weighted fast SE images acquired 6 months after a microfracture procedure in a 29-year-old man show **hyperintense signal** in the repair cartilage with **good fill** over the lateral femoral condyle (arrow)

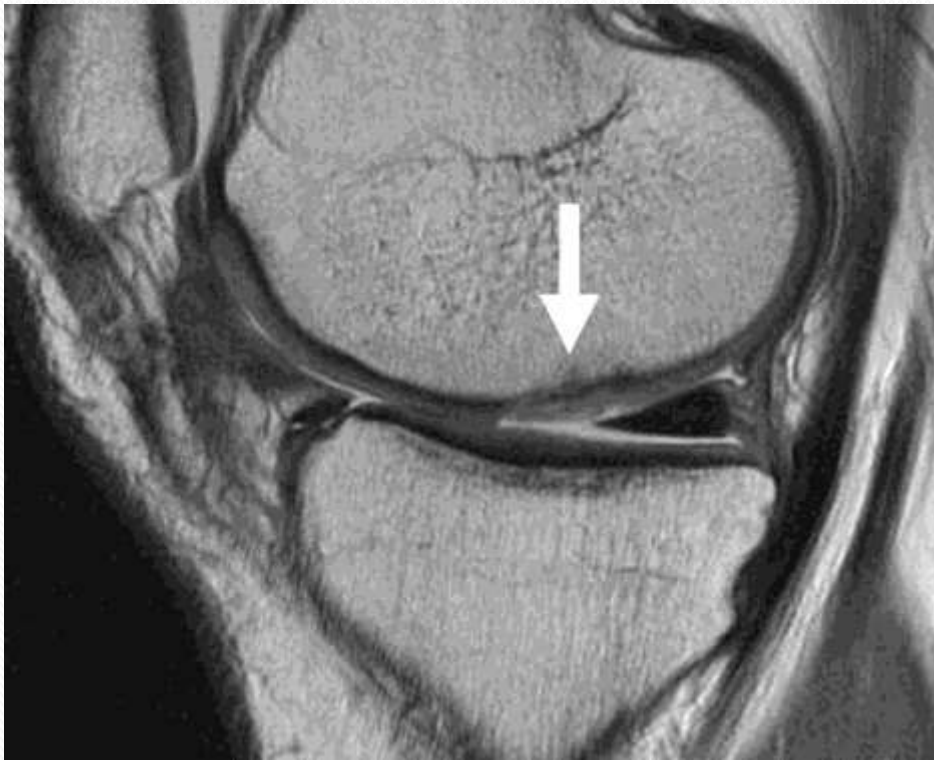
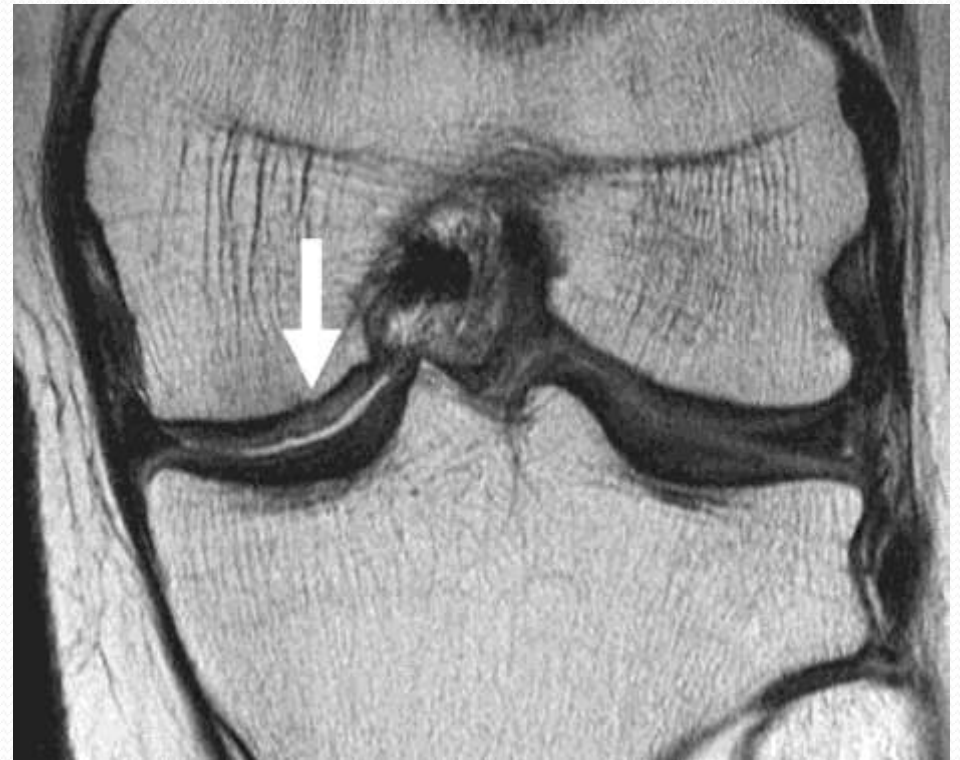
Sagittal and coronal intermediate-weighted fast SE images acquired 6 months after a microfracture procedure in a 50-year-old man show **hyperintense** signal and **superficial irregularity** in the reparative cartilage over the medial femoral condyle (arrow)

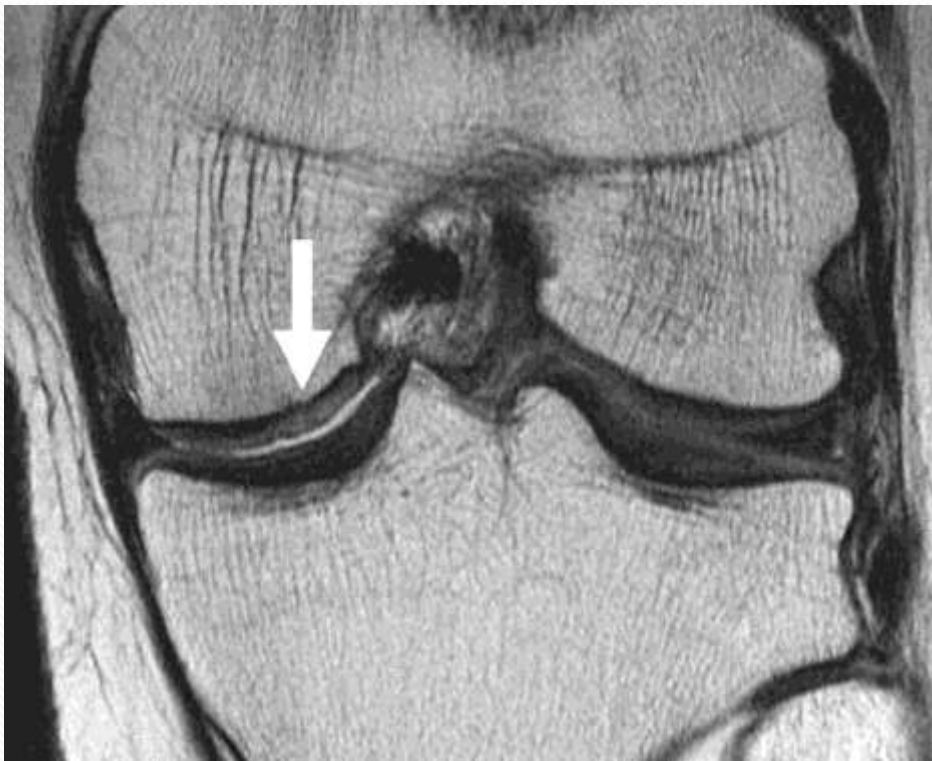
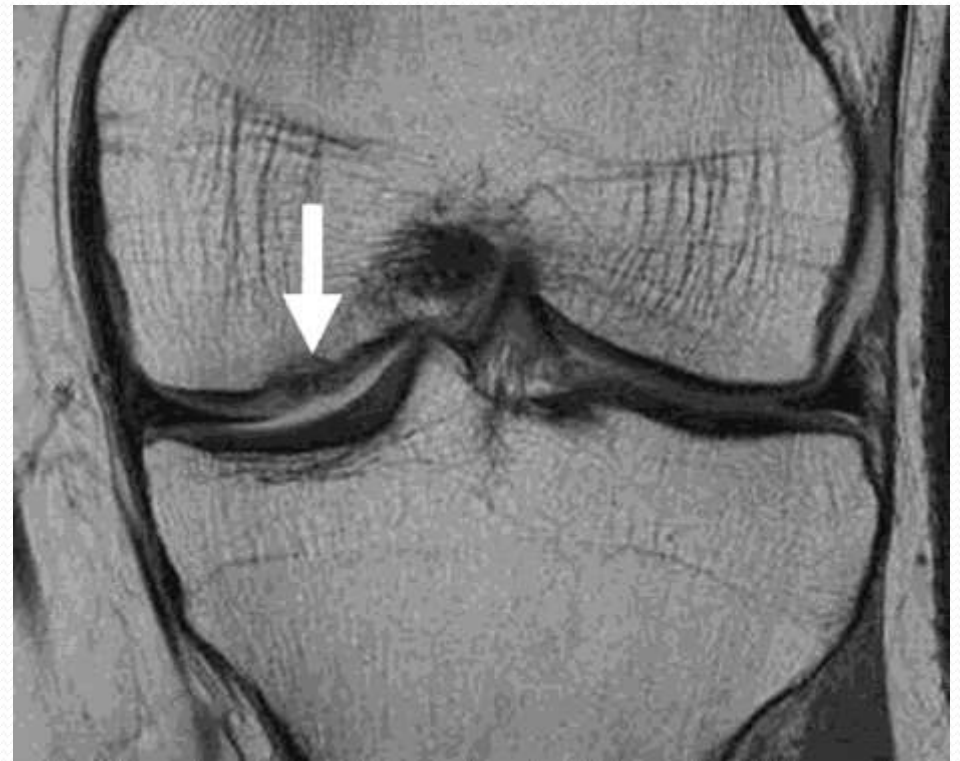
Four year follow-up exam (right) shows **superficial irregularity** of the reparative fibrocartilage, but no exposed subchondral bone

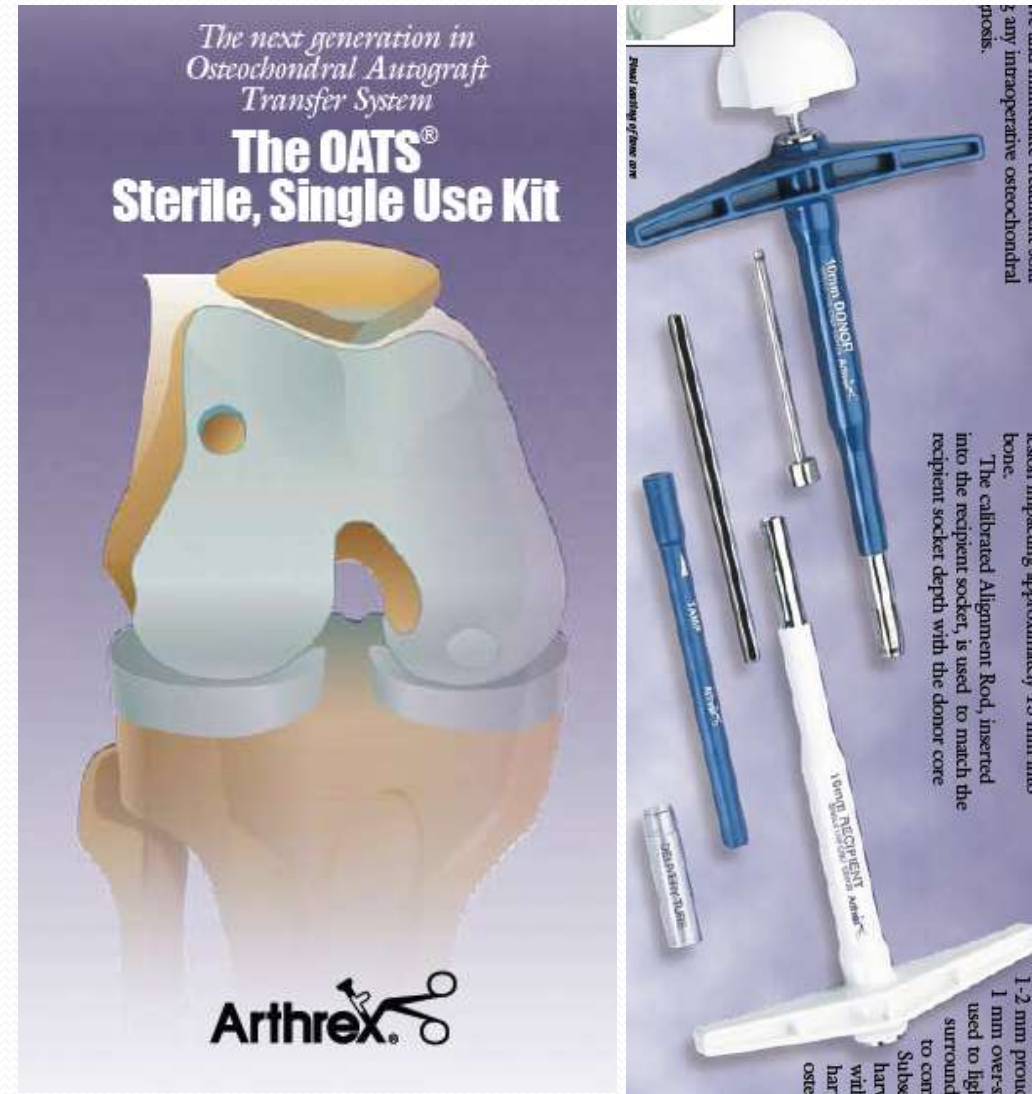
# Osteochondral Autograft Transplantation

- OAT
- Transfer of osteochondral plug from non-weight bearing region of knee to site of chondral damage
  - Most common harvest site
    - Lateral femoral condyle non-weight bearing surface
      - Intercondylar region
      - Peripheral portion of LFC
- Most frequently performed in knee and ankle

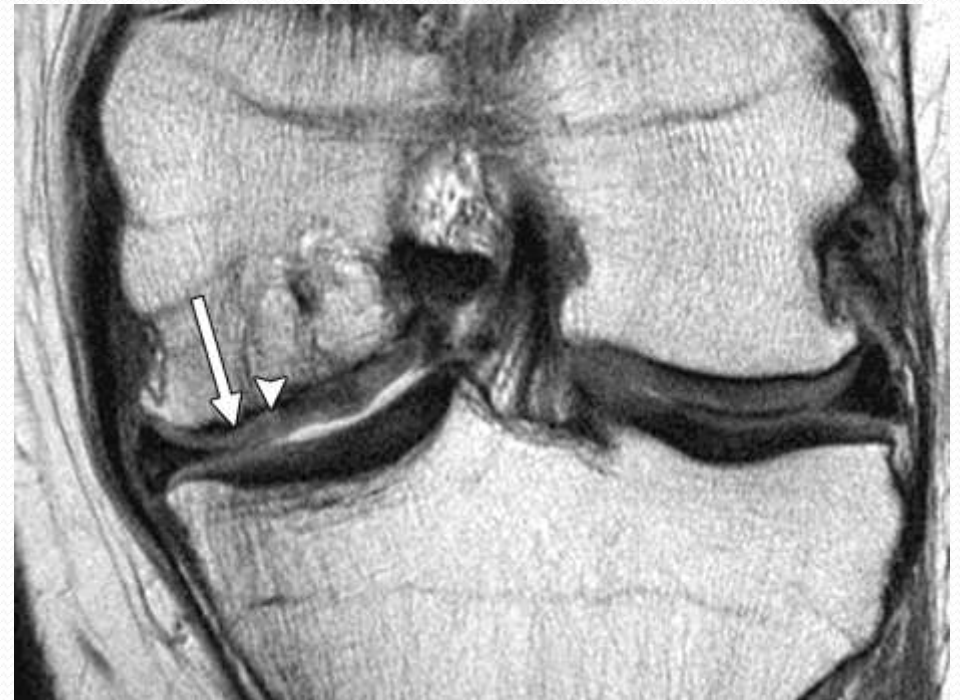
2 years after surgery

Coronal intermediate-weighted fast SE image acquired 2 years after mosaicplasty in a 36-year-old woman shows **good integration** of osteochondral plugs into the medial femoral condyle, with a **slight prominence of cartilage over the most medial plug** (arrow)

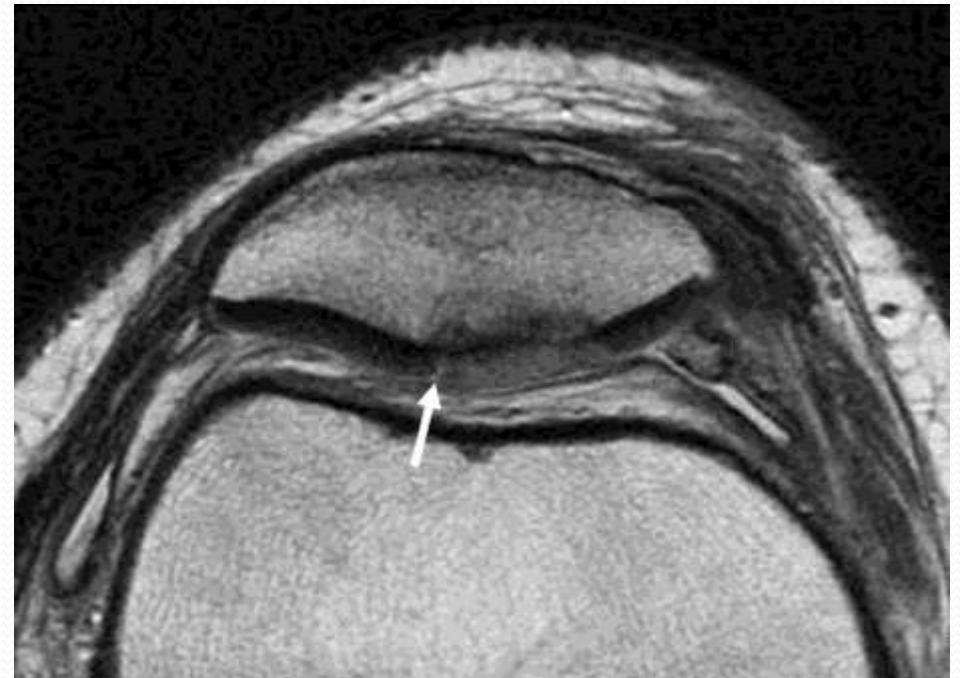
Axial intermediate-weighted image after mosaicplasty in 17 year old boy. Subchondral plate is flush, **small fissure at medial margin** of articular surface. Plugs have incorporated.

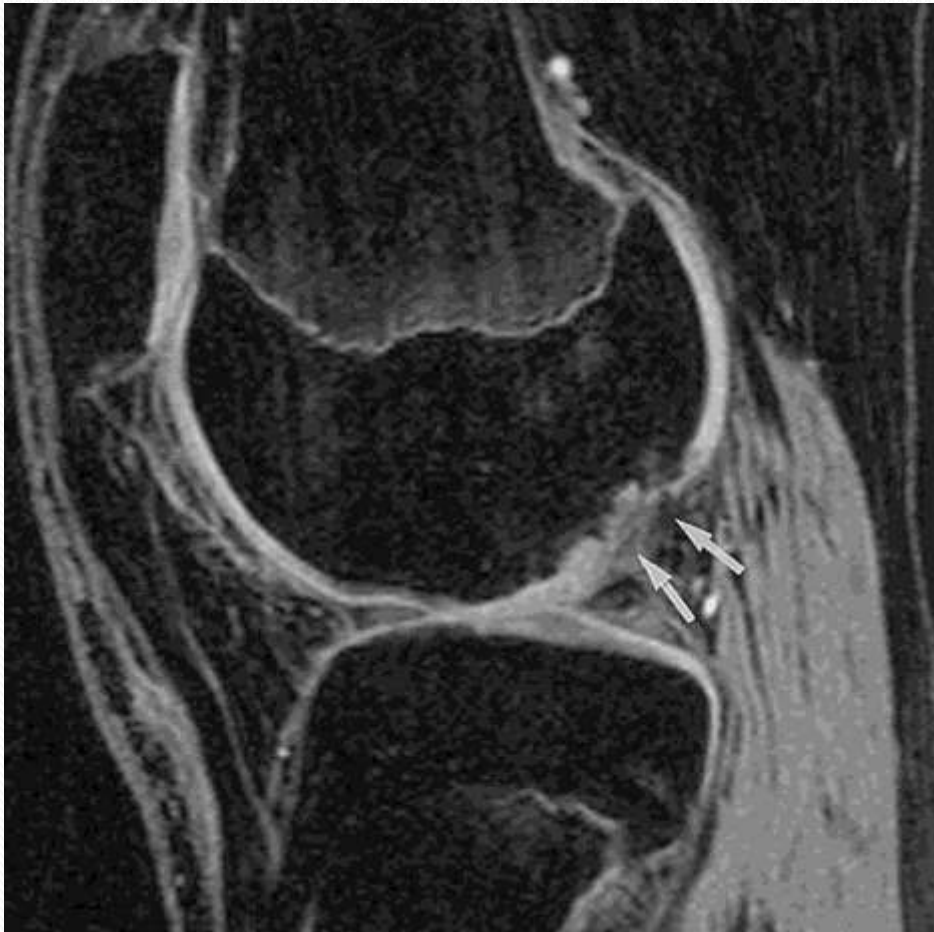
**Graft incongruence in a 27-year-old man after osteochondral autograft transplantation**

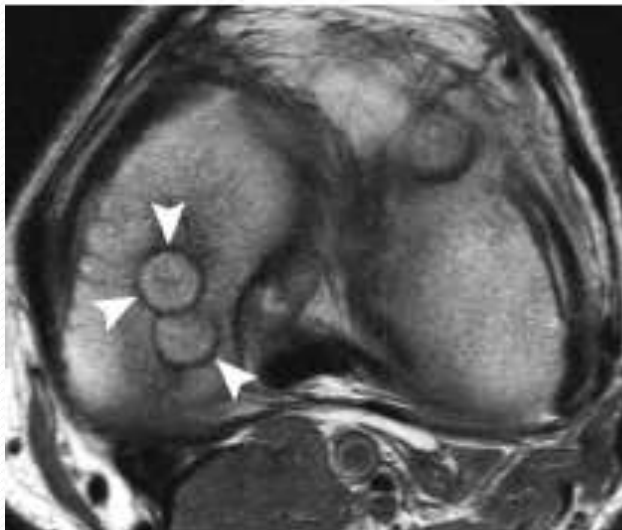
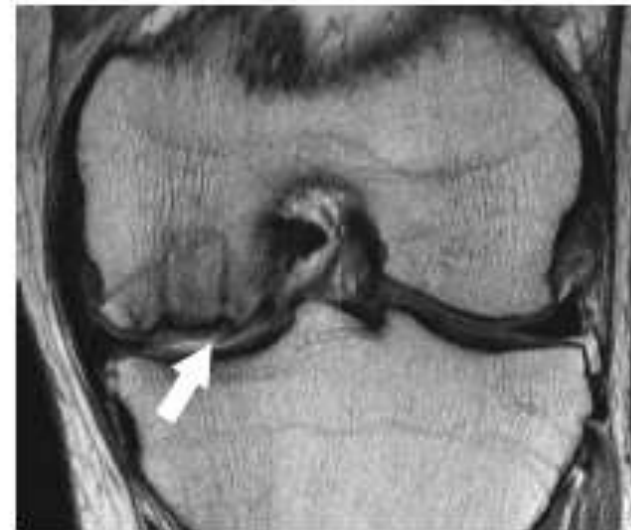
**Figs. 28-A through 28-D** Magnetic resonance images of the knee in a fifty-two-year-old patient, made after the transfer of two autologous osteochondral plugs. Sagittal fat-suppressed (Fig. 28-A) and non-fat-suppressed (Fig. 28-B) fast-spin-echo images demonstrate osseous incorporation of the plugs. Note the slight sclerosis in the side wall of the plugs in the axial plane (white arrowheads, Fig. 28-C), reflecting the "press-fit" technique. Although there is slight depression of the subchondral bone over the anterior plug (Fig. 28-B, black arrow), the cartilage surface remains flush. A fissure at the lateral interface with the native cartilage is seen on the coronal magnetic resonance image (Fig. 28-D, white arrow). There is a degenerative pattern of partial-thickness cartilage loss over the medial tibial plateau.

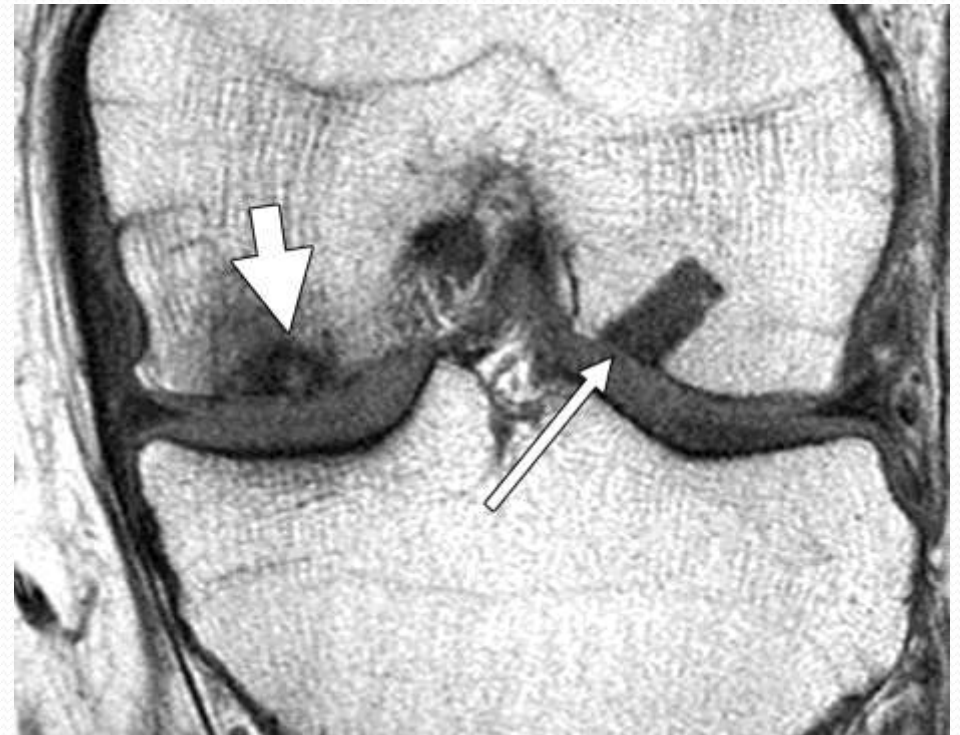
Sagittal inversion-recovery fast SE and coronal intermediate-weighted fast SE images acquired 3 months after mosaicplasty in a 40-year-old man. Good incorporation of plugs, however there is focal collapse of subchondral bone, central cystic change, and subchondral depression. Donor site is filled with fibrocartilage.

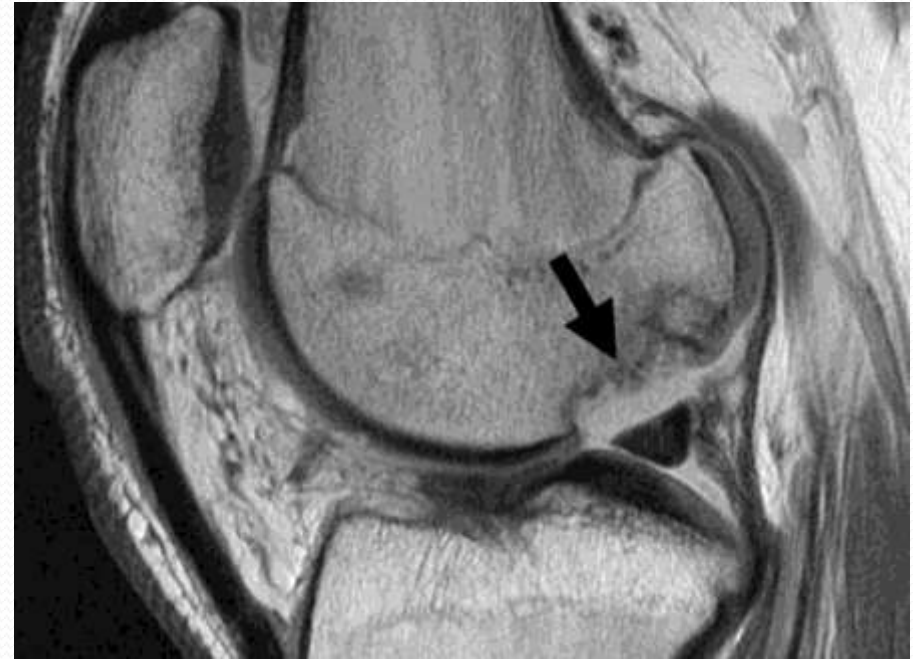
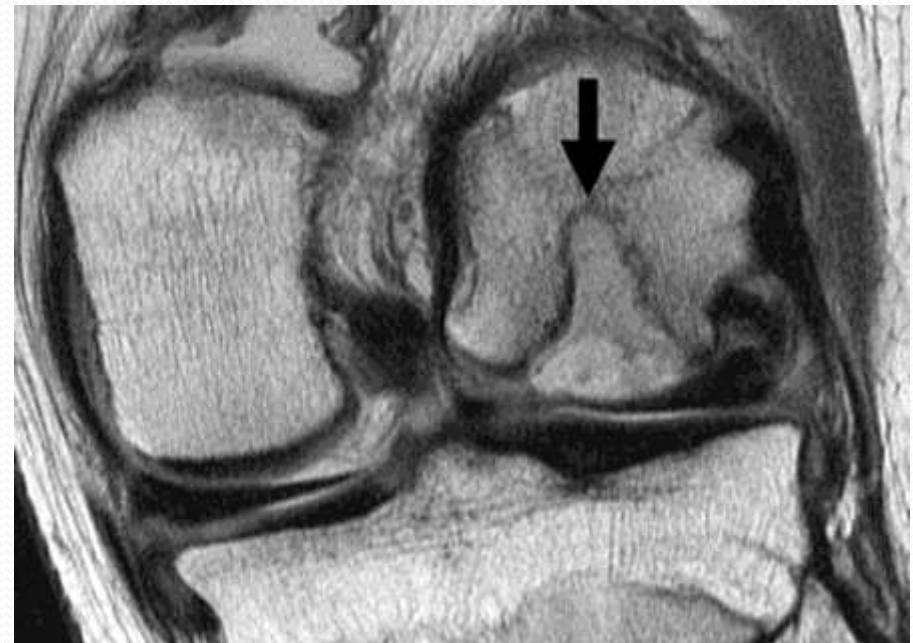
Sagittal and coronal intermediate-weighted fast SE images acquired 5 months after transplantation of an osteochondral autograft over the lateral femoral condyle in a 14-year-old boy show a failure of repair

- Poor integration of graft with native bone
  - Subchondral cysts with fluid signal
  - Graft osteonecrosis
  - Depressed subchondral bone
- Severe fibrillation of adjacent cartilage
- Persistent synovitis
  - Normal effusion and synovitis may persist up to 2 years
- Persistent bone marrow edema in/around graft
  - Normal edema in 50% patients during first 12 months with gradual reduction afterwards

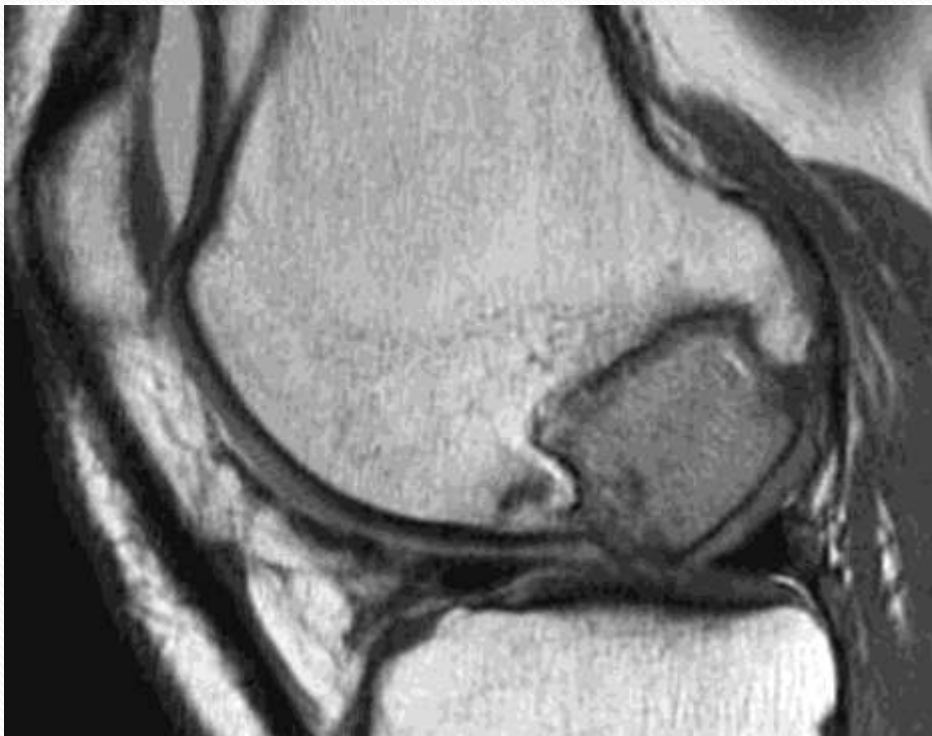
20 months post initial  
surgery

# Allograft Revision with Autograft plug

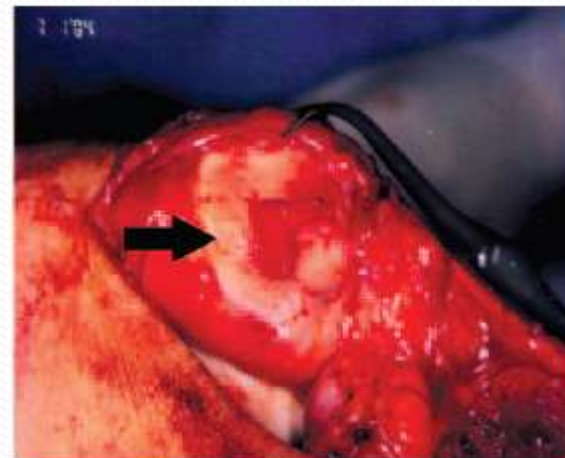
- Two-stage procedure
  - First biopsy of normal hyaline cartilage
    - Typically trochlea or intercondylar notch
    - In vitro culture of chondrocytes for 6 wks
  - Second reimplant chondrocytes into cartilage defect that is covered by watertight autologous periosteal flap or commercially available membrane
    - Periosteal flap harvested from proximal medial tibia
    - flap secured by fibrin glue or sutures

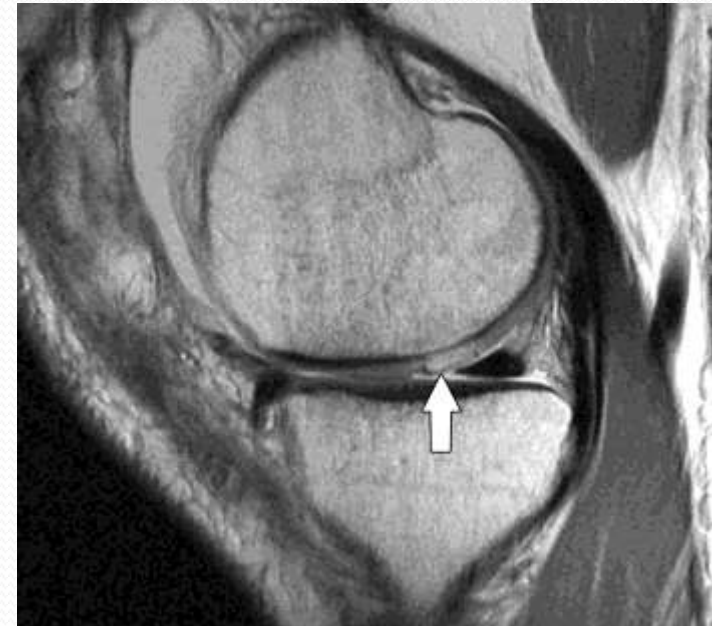
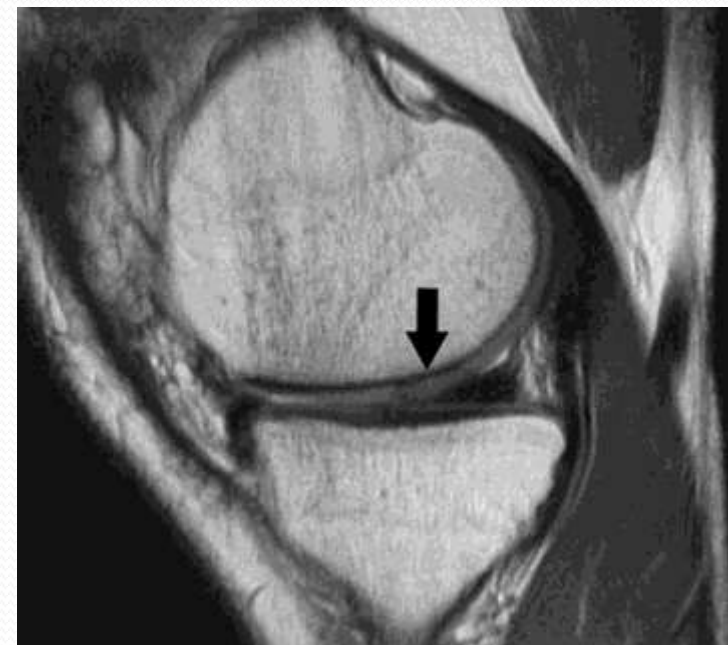
Sagittal intermediate-weighted fast SE images acquired after implantation of an autologous chondrocyte graft over the medial femoral condyle in a 31-year-old man show gradual maturation of the graft

- Signal Intensity-PD
  - Initial hyperintense
  - Late postoperative period signal decreases steadily until approaching that of native cartilage

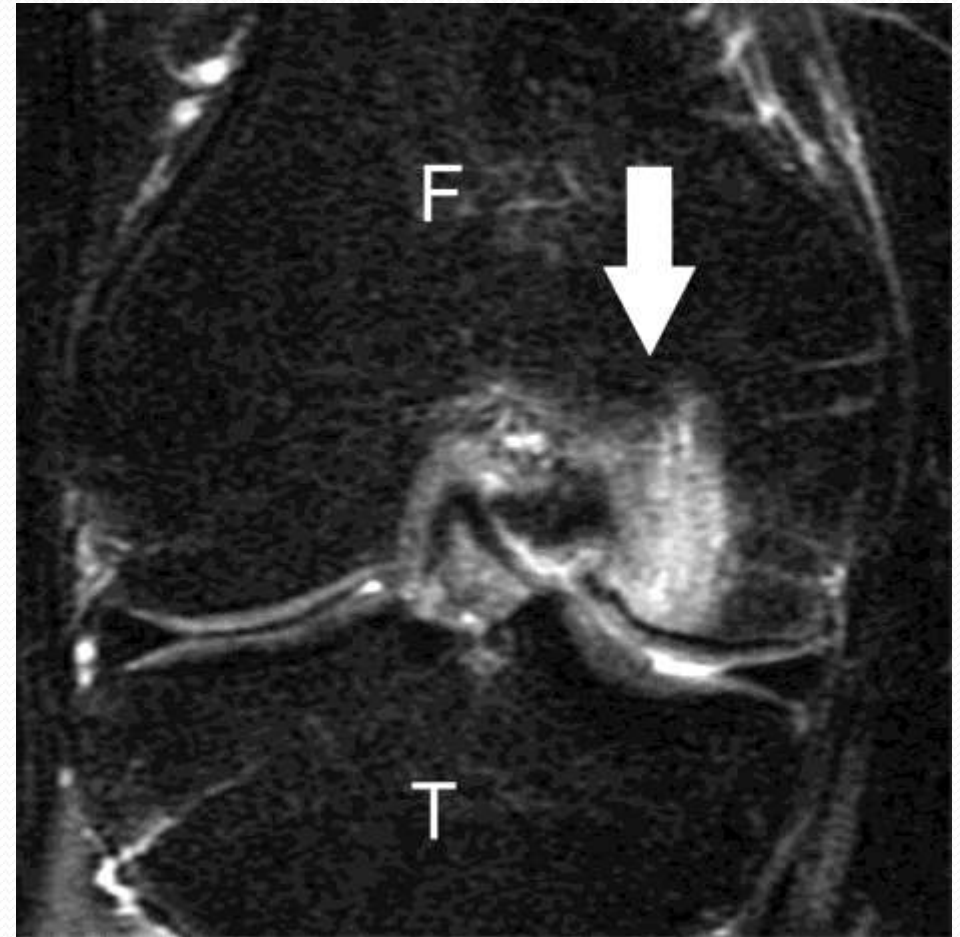
**Coronal STIR image obtained after autologous chondrocyte implantation in a 39-year-old man shows signal intensity characteristic of edema in the marrow adjacent to the site of cartilage repair**

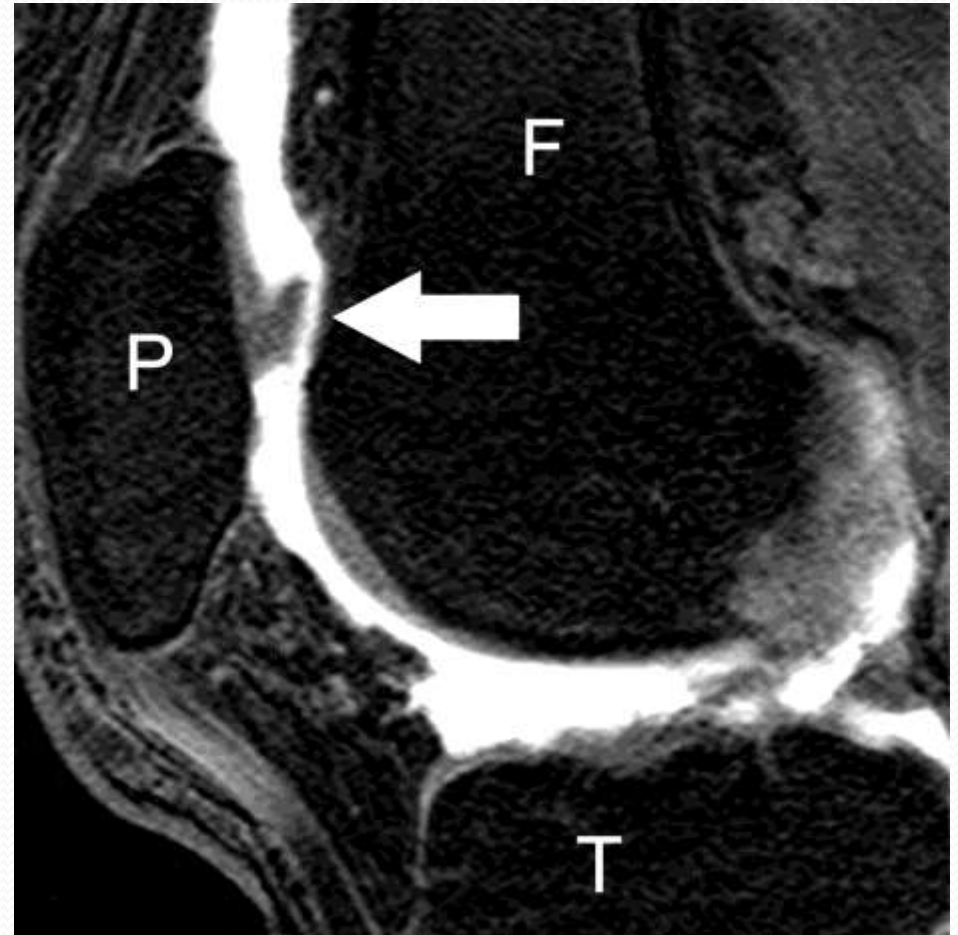
Sagittal spoiled GRE MR arthrogram, obtained in a 30-year-old man 10 months after a right patellar autologous chondrocyte implantation, shows displaced delamination with folding of a retropatellar cartilage flap (arrow)

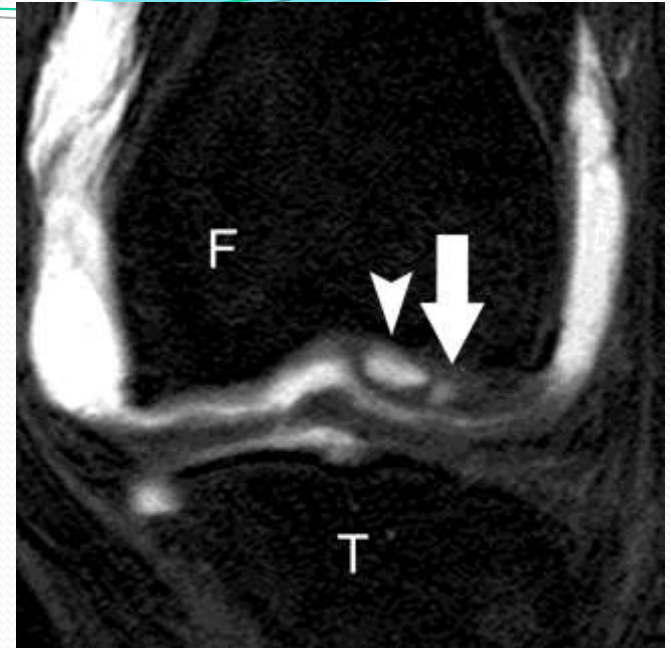
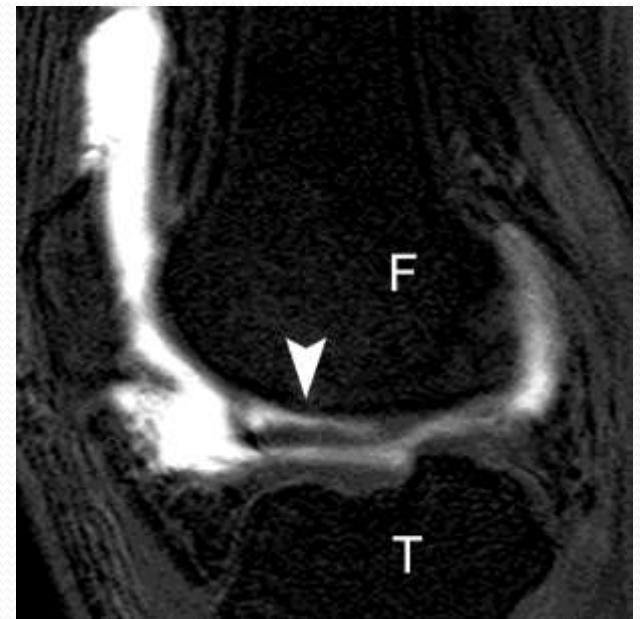
Coronal and sagittal spoiled GRE MR arthrograms obtained in a 59-year-old woman 1 month after autologous chondrocyte implantation show a small cyst (arrow) and adjacent partial delamination (arrowhead) in the interface between native and transplanted cartilage at the left lateral femoral condyle

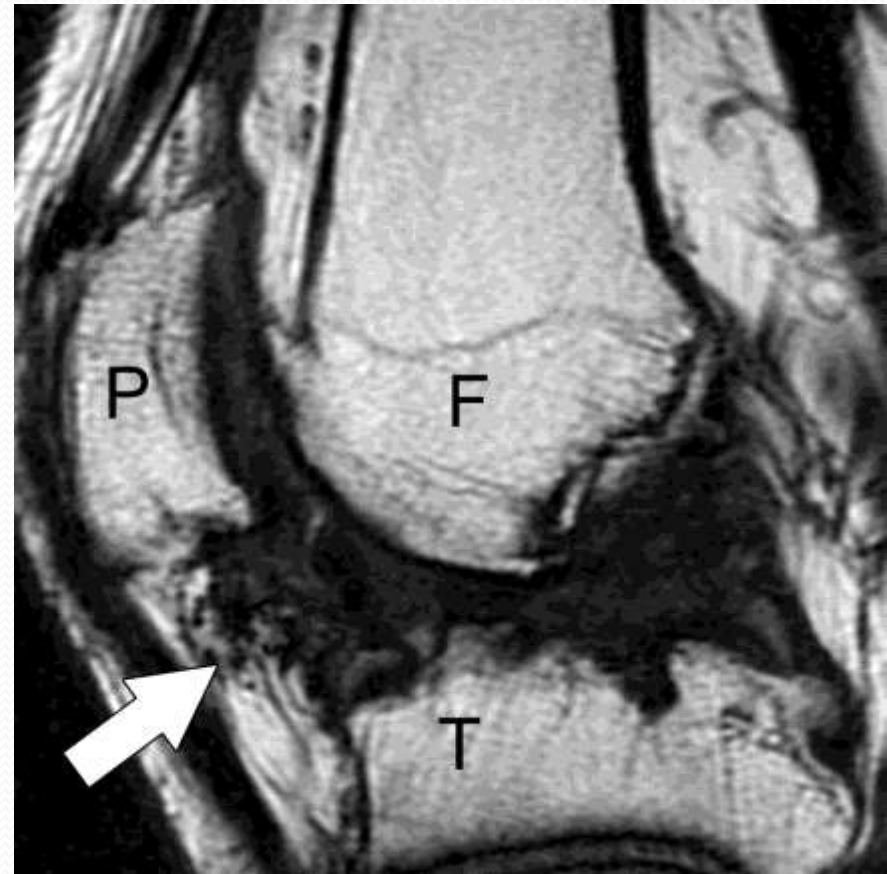
58-year-old man 18 months after autologous chondrocyte implantation and surgical elevation of the tibial tubercle, shows low-signal-intensity material (arrow) suggestive of intraarticular adhesions in the infrapatellar fat pad)

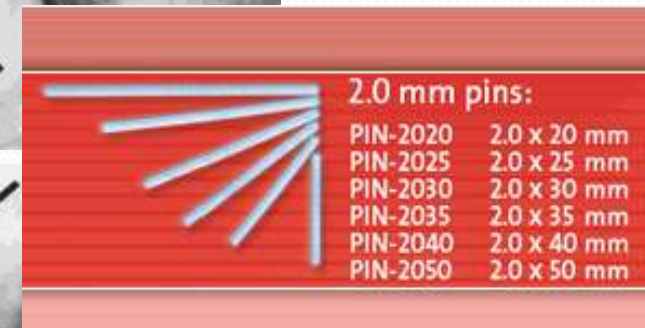
- Biodegradable pins made of polydioxanone or other
  - Osteochondral fractures
  - Chondral flaps
  - Allografts
- Strength lost 18-36wks
- Generally resorb within 6-24 months
- Resultant synthetic debris cleared predominately by macrophages

- Biodegradable Pins
  - Linear low T1 signal intensity during first 6 months
  - By end of 1<sup>st</sup> year, pin sites have high linear T2 signal due to hydrolyzed debris or fluid
  - After 2 years, 80% pins are not visible at MR

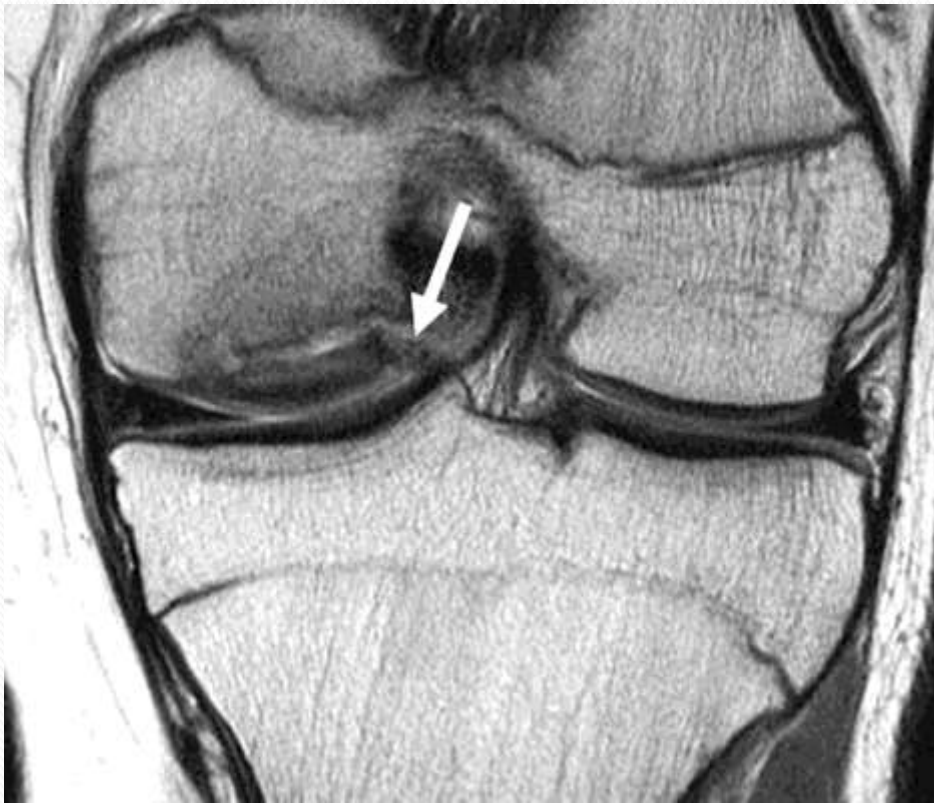
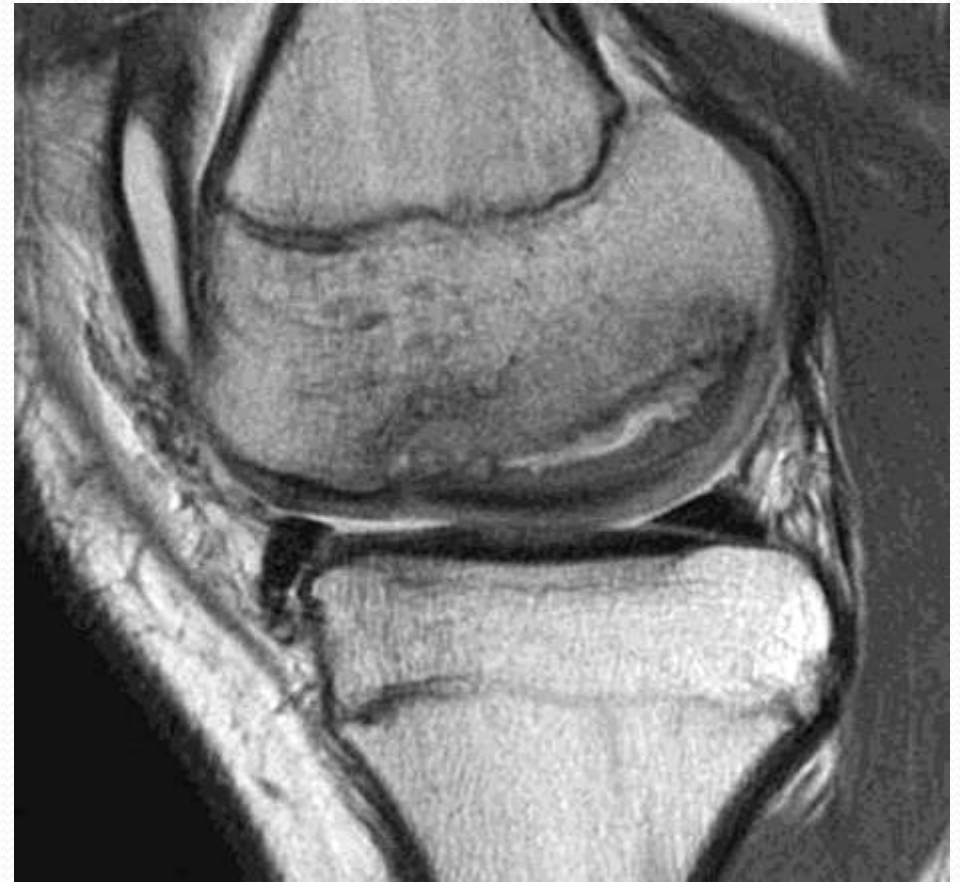
**Coronal and sagittal intermediate-weighted fast SE images acquired in a 16-year-old boy show features of unstable osteochondritis dissecans, with a focal fissure (arrow) that extends into the interface between the donor site and devitalized subchondral bone**

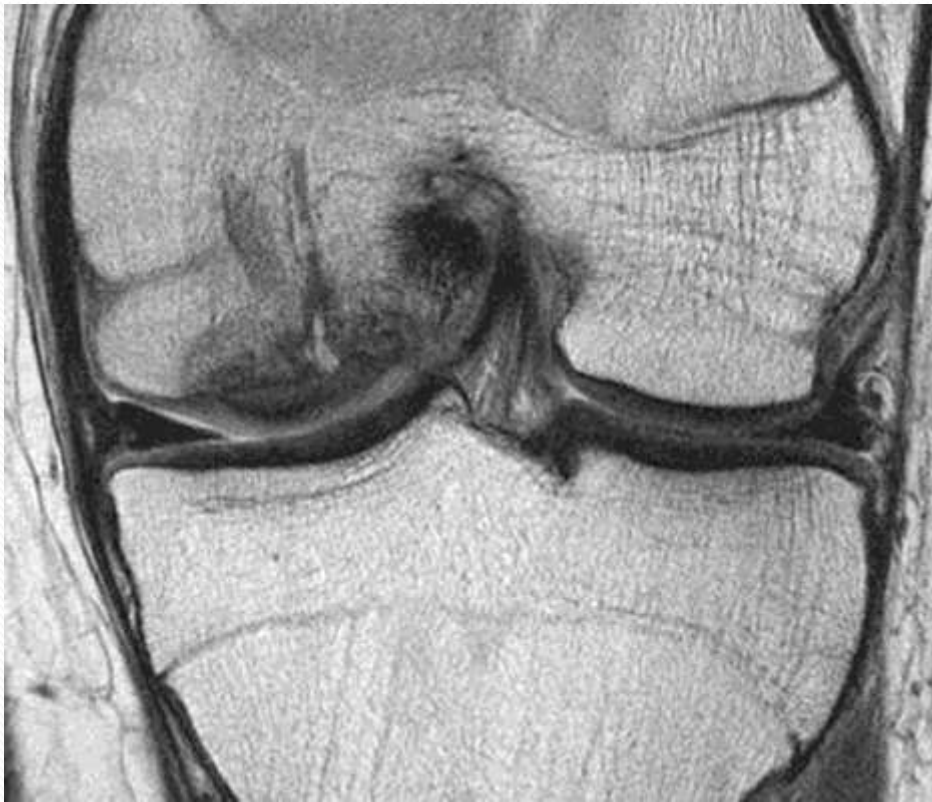
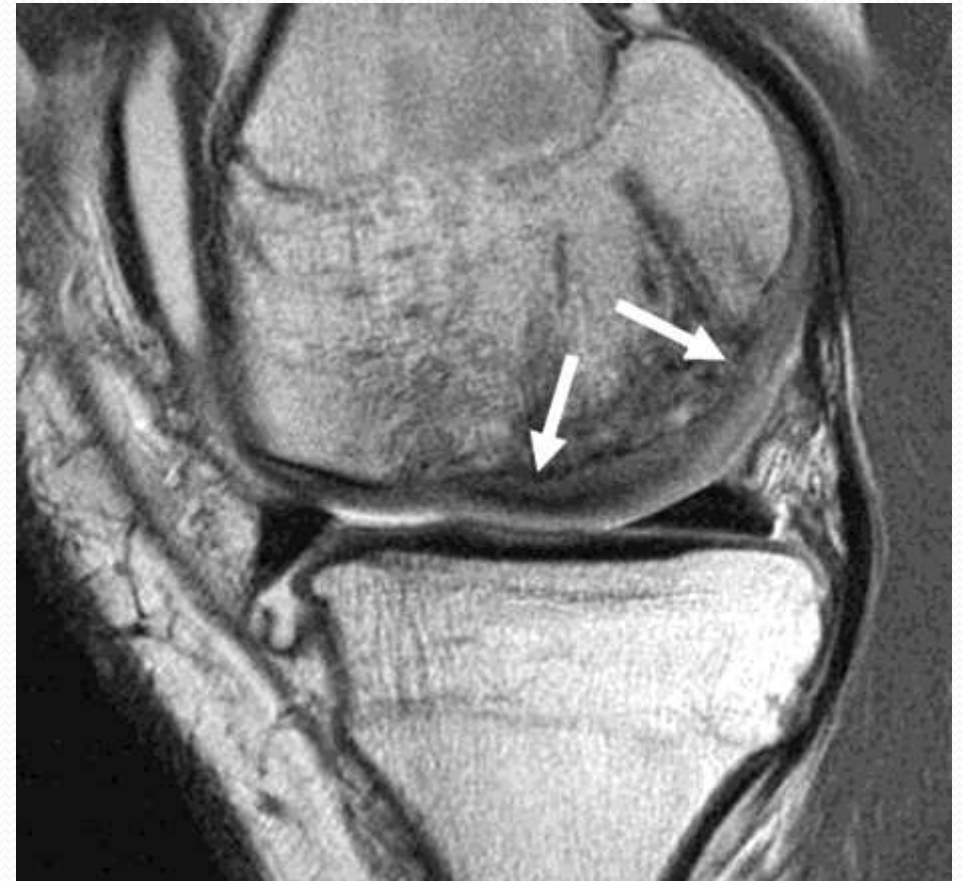
**Coronal (a) and sagittal (b) intermediate-weighted fast SE images acquired in a 16-year-old boy show features of unstable osteochondritis dissecans status post pinning**
